REPORTNUMBER: 202404-26024

Report

Subject	Report
Inspection date/location	22.04.2024 Dick Automobile e.K., Ernst-Abbe-Str. 2, DE-36179 Bebra
Client	Dick Automobile e.K., Otto-Hahn-Str. 4-6, DE-36179 Bebra
Registration number	UN-SW960
Vehicle Identification Number	ZCFA775B602676761

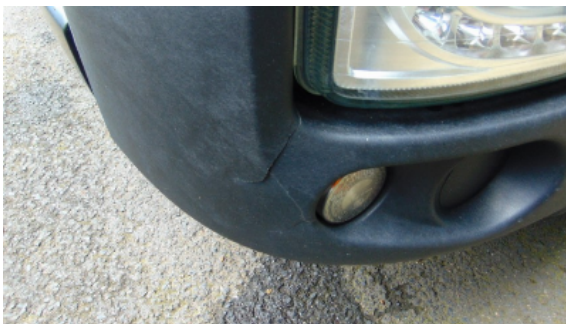
Image 1: Siehe Pos.1

Nr.	Component	Damage	Severity	Comment
1	Bumper front	Crack	Slight	
2	Side panel left	Dent	Slight	
3	Tailgate	Paint chipping	Severe	
4	Side panel right	Scratch	Slight
