REPORTNUMBER: 202403-25716

Report

Subject	Report
Inspection date/location	27.03.2024 Dick Automobile e.K., Ernst-Abbe-Str. 2, DE-36179 Bebra
Client	Dick Automobile e.K., Otto-Hahn-Str. 4-6, DE-36179 Bebra
Registration number	K-UM1088
Vehicle Identification Number	WDF44760113367809

Subject	Report
Client	Dick Automobile e.K., Otto-Hahn-Str. 4-6, DE-36179 Bebra
Inspection date/location	27.03.2024 Dick Automobile e.K., Ernst-Abbe-Str. 2, DE-36179 Bebra
Registration number	K-UM1088
Vehicle type	Van
Manufacturer	Mercedes-Benz
Model / Sales description	Vito 114 CDI Komp.
Key numbers HSN/TSN	1313 / BRI
Vehicle identification number	WDF44760113367809
Previous owners	2
First registration	05.12.2017
Mileage	101.186 km
Colour / Colour Code	
Fuel Type	Diesel
Cubic Capacity / Power	2.143 cm ³ / 100 kW
Number of doors / seats	4 / 2
Transmission	Automatic transmission
Number of keys	2
Last maintenance	24.11.2021 / 76.389 km
Next vehicle inspection	
Service documentation	Available
Trailer coupling	No
Rain sensor	Available
Operating manual	Available
Repainting	Found Plastic parts could not be evaluated by means of paint thickness measurement.
Inspection Condition	non-dismantled, roadworthy, traff

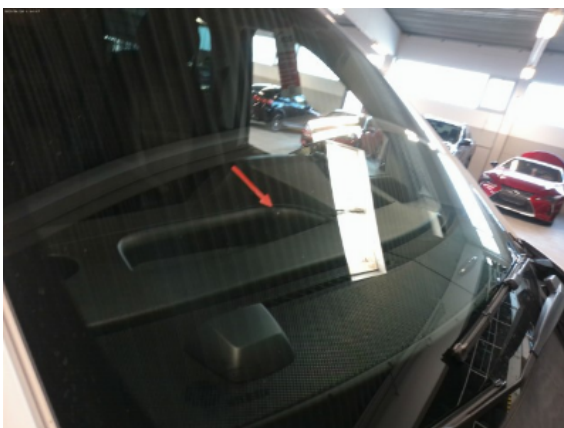
Image 1: Siehe Pos.1

Nr.	Component	Damage	Severity	Comment
1	Windshield	Stone chip	Slight	
2	Bonnet	Crack	Slight	
3	Bumper front	Scratch	Slight	
4	Mirror cap left	Scratch	Slight	
5	Door FL	Scratch	Slight	
6	Tailgate	Deformation	Severe	
7	Bumper rear	Deformation	Slight	
8	Door RR	Scratch	Slight	
9	Door FR	Scratch	Severe	
10	Fender ri	Scratch	Slight
