REPORTNUMBER: 202403-25722

Report

Subject	Report
Client	Dick Automobile e.K., Otto-Hahn-Str. 4-6, DE-36179 Bebra
Inspection date/location	27.03.2024 Dick Automobile e.K., Ernst-Abbe-Str. 2, DE-36179 Bebra
Registration number	K-UM 1087
Vehicle type	Minivan/Minibus
Manufacturer	Mercedes-Benz
Model / Sales description	Vito 114 CDI Komp.100 Aut.
Key numbers HSN/TSN	1313 / BRJ
Vehicle identification number	WDF44760113369192
Previous owners	2
First registration	05.12.2017
Mileage	87.692 km
Colour / Colour Code	
Fuel Type	Diesel
Cubic Capacity / Power	2.143 cm ³ / 100 kW
Number of doors / seats	4 / 2
Transmission	Automatic transmission
Number of keys	2
Last maintenance	26.07.2021 / 36.359 km
Next vehicle inspection	01.01.2024
Service documentation	Available
Trailer coupling	No
Rain sensor	Available
Operating manual	Available
Repainting	Not Found
	Plastic parts could not be evaluated by means of paint thickness measurement.
Inspection Condition	non-dismantled, roadworthy, traffic safe

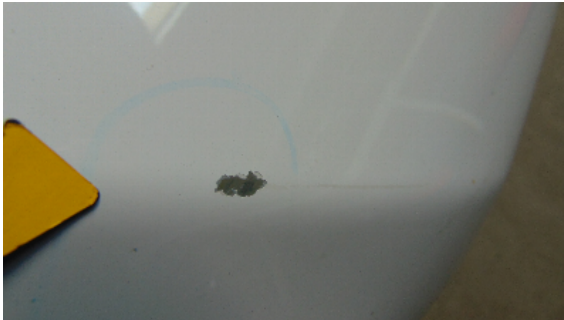
Image 1: siehe pos.1

Nr.	Component	Damage	Severity	Comment
1	Bonnet	Stone chip	Medium	
2	Bonnet	Dent	Medium	
3	Bumper front	Scratch	Medium	
4		Dent	Medium	
5	Door FR	Scratch	Medium	
6	Door RR	Scratch	Medium	
7	Bumper rear	Scratch	Medium	
8	Tailgate	Scratch	Medium	
9	Side panel left	Scratch	Medium	
10	Door FL	Scratch	Medium	
11	Fender le	Scratch	Medium
