REPORTNUMBER: 202404-26033

## Report

<b>Subject</b>	Report
<b>Inspection date/location</b>	22.04.2024   Dick Automobile e.K., Ernst-Abbe-Str. 2, DE-36179 Bebra
<b>Client</b>	Dick Automobile e.K., Otto-Hahn-Str. 4-6, DE-36179 Bebra
<b>Registration number</b>	K-UM1139
<b>Vehicle Identification Number</b>	WDF44760113376040

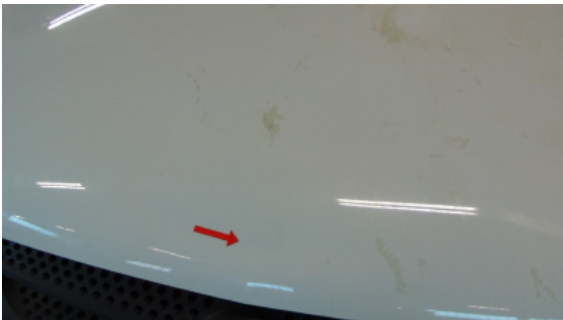
Image 1: Siehe Pos.1

Nr.	Component	Damage	Severity	Comment
1	Bonnet		Severe	
2	Windshield		Slight	
3	Door FL	Stone chip	Slight	
4	Tailgate	Scratch	Slight	
5	Side panel right	Scratch	Slight	
6	Door RR	Scratch	Slight	
7	Door FR	Stone chip	Medium
