REPORTNUMBER: 202403-25696

## Report

<b>Subject</b>	Report
<b>Inspection date/location</b>	26.03.2024   Dick Automobile e.K., Ernst-Abbe-Str. 2, DE-36179 Bebra
<b>Client</b>	Dick Automobile e.K., Otto-Hahn-Str. 4-6, DE-36179 Bebra
<b>Registration number</b>	DU-XD1025
<b>Vehicle Identification Number</b>	WDF44760113579381

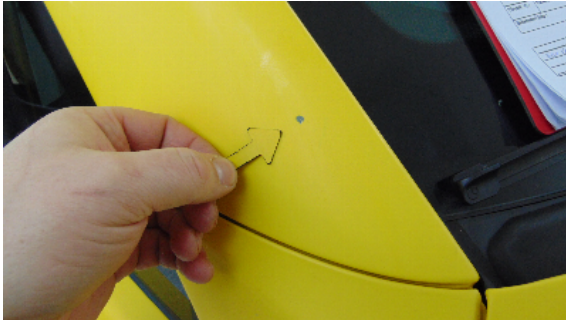
Image 5: siehe pos.6

Nr.	Component	Damage	Severity	Comment
1	Seat FL		Medium	
2	Seat FR		Medium	
3	Bonnet	Stone chip	Medium	
4	Bumper front	Stone chip	Medium	
5	Windshield	Crack	Severe	
6		Stone chip	Medium	
7	Mirror cap right	Scratch	Medium	
8	Door FR	Scratch	Medium	
9	Bumper rear	Scratch	Medium	
10	Door FL	Scratch	Medium	
11	Complete vehicle		Severe
