REPORTNUMBER: 202403-25479

Report

Subject	Report
Client	Dick Automobile e.K., Otto-Hahn-Str. 4-6, DE-36179 Bebra
Inspection date/location	11.03.2024 Dick Automobile e.K., Ernst-Abbe-Str. 2, DE-36179 Bebra
Registration number	DU-XD1014
Vehicle type	Estate Car
Manufacturer	Mercedes-Benz
Model / Sales description	Vito 116 CDI Komp.
Key numbers HSN/TSN	1313 / BQK
Vehicle identification number	WDF44760113579402
Previous owners	1
First registration	27.03.2019
Mileage	249.766 km
Colour / Colour Code	
Fuel Type	Diesel
Cubic Capacity / Power	2.143 cm ³ / 120 kW
Number of doors / seats	5 / 5
Transmission	Automatic transmission
Number of keys	2
Last maintenance	22.11.2019 / 45.048 km
Next vehicle inspection	01.03.2025
Service documentation	Available
Trailer coupling	Fix
Rain sensor	Available
Operating manual	Available
Repainting	Found Plastic parts could not be evaluated by means of paint thickness measurement.
Inspection Condition	non-dismantled, roadworthy, traffic safe

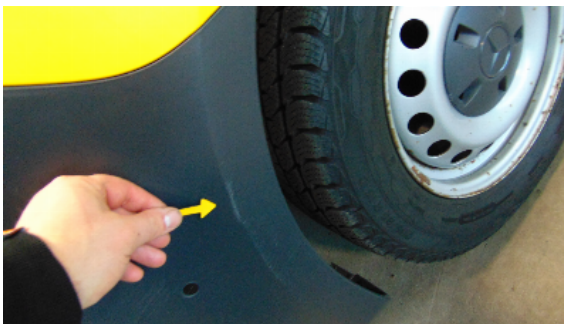
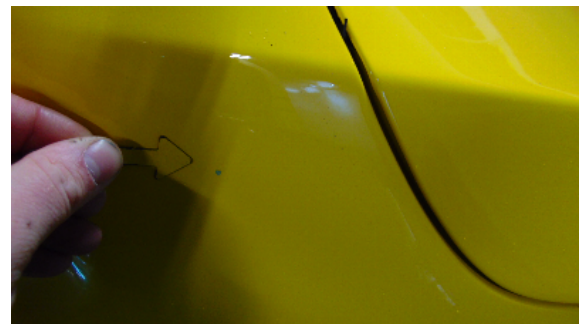
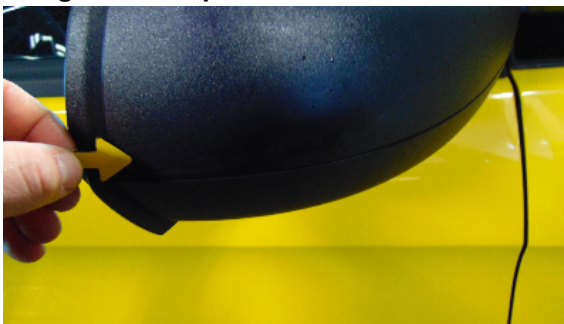
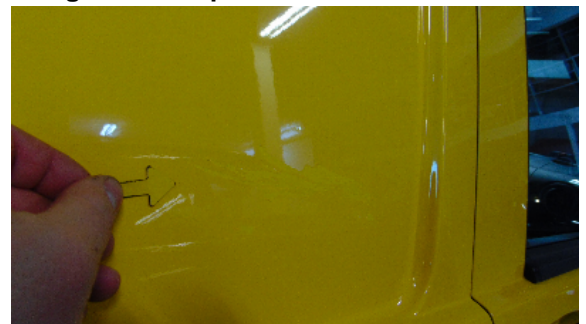
Damage pictures

Nr.	Component	Damage	Severity	Comment
1	Bumper front	Scratch	Slight	
2	Fender ri	Stone chip	Slight	
3	Mirror cap right	Scratch	Slight	
4	Door RR	Scratch	Slight	
5	Bumper rear	Scratch	Slight	
6	Tailgate panel	Scratch	Slight	
7	Side panel left	Scratch	Slight	
8	Door FL	Scratch	Slight	
9	Fender le	Dent	Medium
