REPORTNUMBER: 202405-26185

Report

Subject	Report
Inspection date/location	04.05.2024 Dick Automobile e.K., Ernst-Abbe-Str. 2, DE-36179 Bebra
Client	Dick Automobile e.K., Otto-Hahn-Str. 4-6, DE-36179 Bebra
Registration number	DU-XD 1030
Vehicle Identification Number	WDF44760113579886

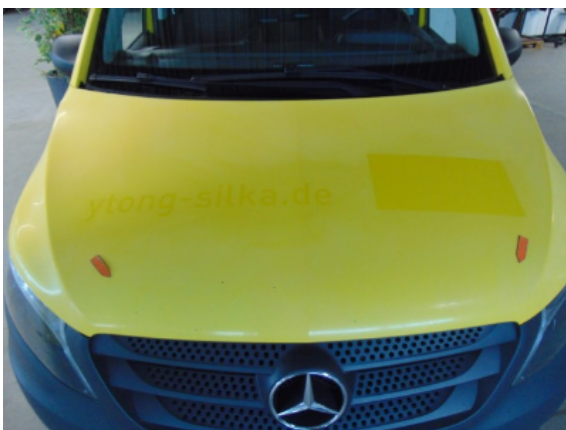
Image 1: Siehe Pos.1

Nr.	Component	Damage	Severity	Comment
1	Bonnet		Medium	
2	Windshield	Stone chip	Slight	
3	Roof	Stone chip	Slight	
4	Fender le		Medium	
5	Door FL		Slight	
6	Door entry FL		Medium	
7	Side panel left		Medium	
8	Fender ri		Medium	
9	A-pillar right	Stone chip	Slight	
10	Door RR		Medium	
11	Side panel right		Medium	
12			Medium

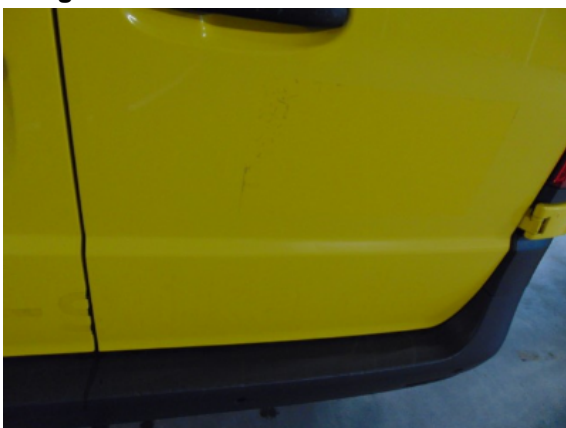
Image 13: Siehe Pos.13

13	Medium
14 Bumper rear	Medium
