REPORTNUMBER: 202404-25986

Report

Subject	Report
Inspection date/location	18.04.2024 Dick Automobile e.K., Ernst-Abbe-Str. 2, DE-36179 Bebra
Client	Dick Automobile e.K., Otto-Hahn-Str. 4-6, DE-36179 Bebra
Registration number	MA-BB425
Vehicle Identification Number	W1V44760113741761

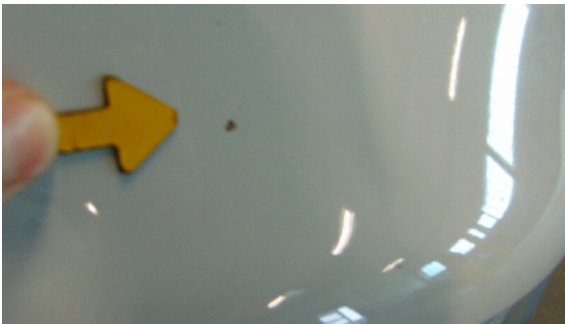
Image 1: siehe pos. 1

Nr.	Component	Damage	Severity	Comment
1	Bonnet	Stone chip	Slight	
2	Bumper front	Stone chip	Slight	
3	Fender ri	Scratch	Slight	
4	Door FR	Scratch	Slight	
5	Door RR	Scratch	Slight	
6	Side panel right	Scratch	Slight	
7	Door FL	Scratch	Slight
