REPORTNUMBER: 202402-25124

Report

Subject	Report
Inspection date/location	12.02.2024 Dick Automobile e.K., Ernst-Abbe-Str. 2, DE-36179 Bebra
Client	Dick Automobile e.K., Otto-Hahn-Str. 4-6, DE-36179 Bebra
Registration number	OF-MB 1503
Vehicle Identification Number	KNAE551CDK6057555

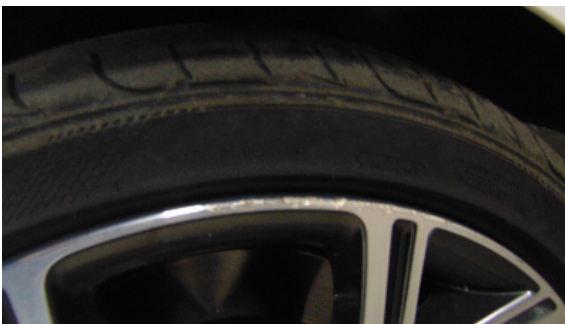
Image 1: siehe pos.1

Nr.	Component	Damage	Severity	Comment
1	Aluminium rim FR	Scratch	Medium	
2	Bonnet	Stone chip	Slight	
3	Roof	Stone chip	Slight	
4	Fender ri	Stone chip	Slight	
5	Mirror cap right	Stone chip	Slight	
6	Door FR	Scratch	Slight	
7	Side panel right	Scratch	Slight	
8	Tailgate panel	Scratch	Slight	
9	Bumper rear	Scratch	Slight	
10	Door FL	Scratch	Slight	
11	Bumper front	Scratch	Slight
