REPORTNUMBER: 202403-25435

Report

Subject	Report
Inspection date/location	07.03.2024 Dick Automobile e.K., Ernst-Abbe-Str. 2, DE-36179 Bebra
Client	Dick Automobile e.K., Otto-Hahn-Str. 4-6, DE-36179 Bebra
Registration number	UN-C1009
Vehicle Identification Number	ZAREAEBN6K7616732

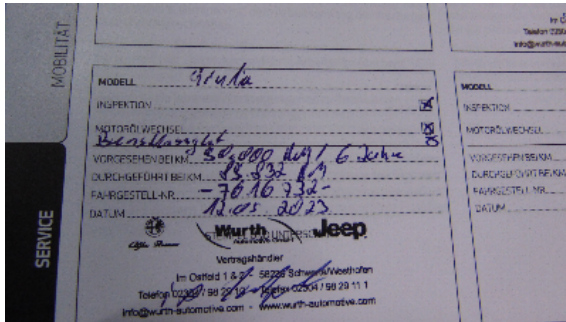
Image 13

INSPEKTION:

MOTORÖLWECHSEL: *Benennung*

VORGESEHENE BEI KM: *50.000 km / 6 Jahre*

DURCHFÜHRT BEI KM: *58.000 km*

FAHRGESTELL-NR.: *-7016732-*

DATUM: *10.03.2024*

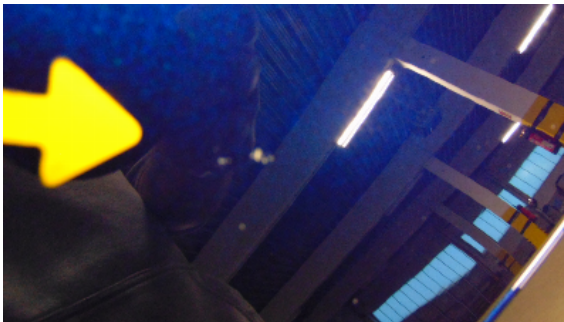
Image 1: siehe pos.1

Nr.	Component	Damage	Severity	Comment
1	Bonnet	Stone chip	Slight	
2	Bumper front	Stone chip	Slight	
3		Scratch	Slight	
4	Bumper rear	Scratch	Slight	
5	Door FL	Scratch	Slight	
6		Scratch	Slight
