REPORTNUMBER: 202408-27378

Report

Subject	Report
Inspection date/location	26.08.2024 Dick Automobile e.K., Ernst-Abbe-Str. 2, DE-36179 Bebra
Client	Dick Automobile e.K., Otto-Hahn-Str. 4-6, DE-36179 Bebra
Registration number	M-AL 1139
Vehicle Identification Number	WBA11CL0107F96144

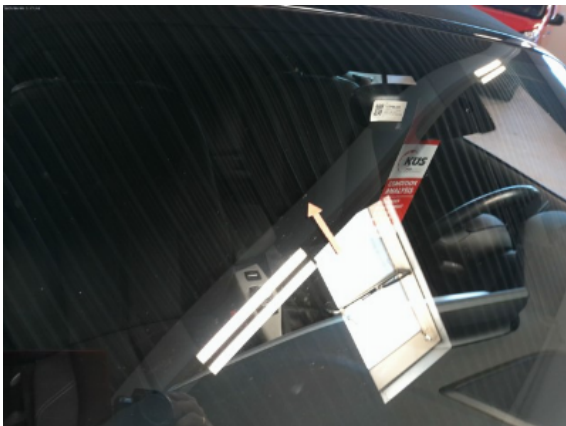
Image 1: Siehe Pos.1

Nr.	Component	Damage	Severity	Comment
1	Windshield	Stone chip	Slight	
2	Bonnet	Stone chip	Slight	
3	Bumper front	Stone chip	Slight	
4	Mirror cap left	Stone chip	Slight	
5	Door FL	Scratch	Slight	
6	Bumper rear	Scratch	Slight	
7	Mirror cap right	Stone chip	Slight	
8	Fender ri	Stone chip	Slight
