REPORTNUMBER: 202410-27817

Report

Subject	Report
Inspection date/location	01.10.2024 Dick Automobile e.K., Ernst-Abbe-Str. 2, DE-36179 Bebra
Client	Dick Automobile e.K., Otto-Hahn-Str. 4-6, DE-36179 Bebra
Registration number	B-CC 2868
Vehicle Identification Number	W0VBE8EB3K8023947

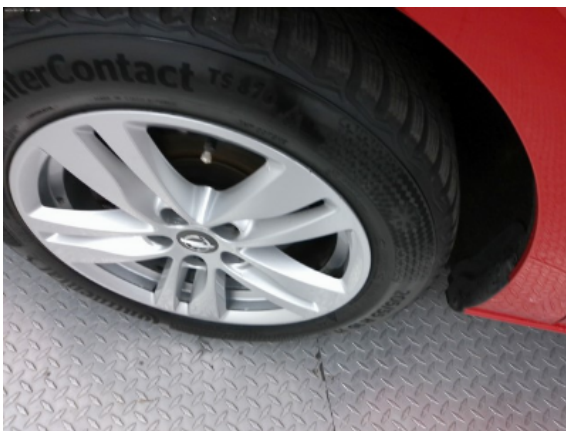
Image 1: Siehe Pos.1

Nr.	Component	Damage	Severity	Comment
1	Aluminium rim FL	Scratch	Slight	
2	Aluminium rim FR	Scratch	Severe	
3	Windshield	Stone chip	Slight	
4	Bonnet	Stone chip	Severe	
5	Bumper front	Stone chip	Medium	
6	Fender le	Stone chip	Slight	
7	Roof frame left	Stone chip	Severe	
8	Side panel left	Stone chip	Slight	
9	Side panel right	Scratch	Slight	
10	Door RR	Scratch	Slight	
11	Fender ri	Stone chip	Slight
