REPORTNUMBER: 202402-25111

Report

Subject	Report
Client	Dick Automobile e.K., Otto-Hahn-Str. 4-6, DE-36179 Bebra
Inspection date/location	09.02.2024 Dick Automobile e.K., Ernst-Abbe-Str. 2, DE-36179 Bebra
Registration number	D-QY 1656
Vehicle type	Estate Car
Manufacturer	Skoda
Model / Sales description	Kodiaq 2.0TSI 4x4 Sportl.140 A
Key numbers HSN/TSN	8004 / ATO
Vehicle identification number	TMBLE9NS5L8033353
Previous owners	1
First registration	03.02.2020
Mileage	191.740 km
Colour / Colour Code	ROT
Fuel Type	Petrol
Cubic Capacity / Power	1.984 cm ³ / 140 kW
Number of doors / seats	5 / 5
Transmission	Automatic transmission
Number of keys	2
Last maintenance	07.07.2023 / 179.121 km
Next vehicle inspection	01.06.2025
Service documentation	Available
Trailer coupling	Swiveling
Rain sensor	Available
Operating manual	Available
Repainting	Not Found Plastic parts could not be evaluated by means of paint thickness measurement.
Inspection Condition	non-dismantled, roadworthy, traffic safe

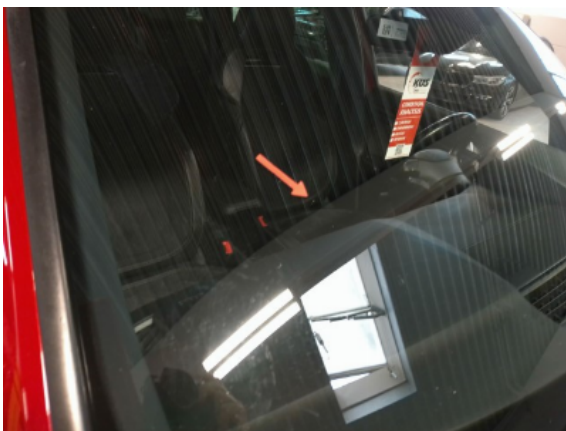
Image 1: Siehe Pos.1

Nr.	Component	Damage	Severity	Comment
1	Windshield	Stone chip	Slight	
2	Bonnet	Stone chip	Slight	
3	Bumper front	Stone chip	Slight	
4	Fender le	Stone chip	Slight	
5	Mirror cap left	Stone chip	Slight	
6	Door RL	Scratch	Slight	
7	Side panel left	Scratch	Slight	
8	Tailgate	Scratch	Slight	
9	Bumper rear	Scratch	Slight	
10	Side panel right	Scratch	Medium	
11	Door RR	Scratch	Slight	
12	Mirror cap right	Stone chip	Slight
