REPORTNUMBER: 202404-26037

Report

Subject	Report
Inspection date/location	22.04.2024 Dick Automobile e.K., Ernst-Abbe-Str. 2, DE-36179 Bebra
Client	Dick Automobile e.K., Otto-Hahn-Str. 4-6, DE-36179 Bebra
Registration number	B-CC4485
Vehicle Identification Number	W0VBE8ESXL8035272

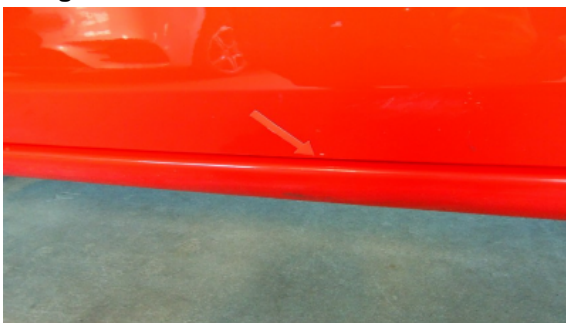
Image 7: Siehe Pos.7

Nr.	Component	Damage	Severity	Comment
1	Aluminium rim RR	Scratch	Slight	
2	Bonnet	Stone chip	Slight	
3	Bumper front	Scratch	Slight	
4	Fender le	Stone chip	Slight	
5	A-pillar left	Stone chip	Slight	
6	Windshield	Stone chip	Slight	
7	Door RL	Scratch	Slight	
8	Side panel left	Dent	Slight	
9	Door RR	Scratch	Slight	
10	Door FR	Scratch	Slight	
11	Fender ri	Stone chip	Slight

- Door r.l.; ~ 265µm
- Side panel le.; ~ 160µm

A sample-like paint thickness measurement showed an increased paint thickness, which is almost certainly due to a repaired damage.
