REPORTNUMBER: 202601-32408

Report

Subject	Report
Inspection date/location	20.01.2026 Dick Automobile e.K., Ernst-Abbe-Str. 2, DE-36179 Bebra
Client	Dick Automobile e.K., Otto-Hahn-Str. 4-6, DE-36179 Bebra
Registration number	M-S2137E
Vehicle Identification Number	WBATS110509D56399

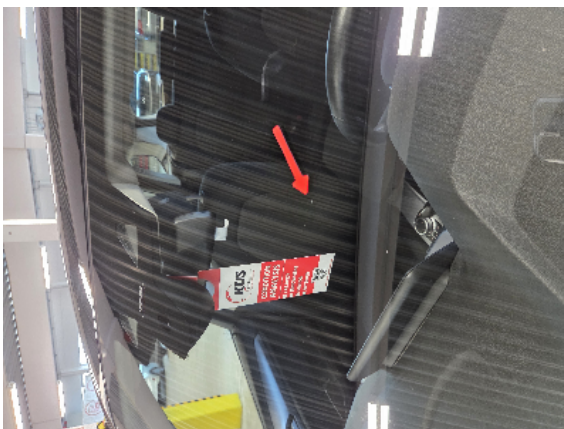
Image 1: Siehe Pos.1

Nr.	Component	Damage	Severity	Comment
1	Windshield	Stone chip	Slight	
2	Bonnet	Stone chip	Slight	
3	Bumper front	Stone chip	Slight	
4	Side panel right	Dent	Slight	
5	Door RR	Dent	Slight
