REPORTNUMBER: 202403-25538

## Report

<b>Subject</b>	Report
<b>Inspection date/location</b>	14.03.2024   Dick Automobile e.K., Ernst-Abbe-Str. 2, DE-36179 Bebra
<b>Client</b>	Dick Automobile e.K., Otto-Hahn-Str. 4-6, DE-36179 Bebra
<b>Registration number</b>	ME-FP555
<b>Vehicle Identification Number</b>	WAUZZZF53KA064466

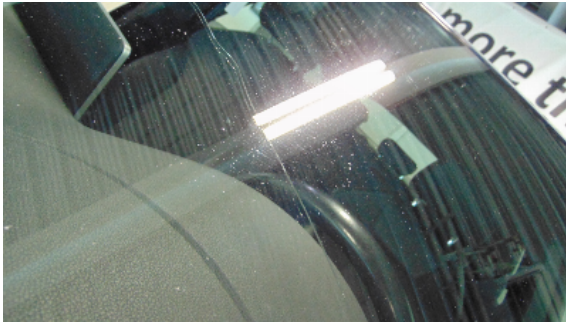
Image 1: siehe pos.1

Nr.	Component	Damage	Severity	Comment
1	Windshield	Crack	Severe	
2	Bonnet	Stone chip	Slight	
3	Bumper front	Stone chip	Slight	
4	Mirror cap right	Scratch	Slight	
5	Tailgate panel	Scratch	Slight
