REPORTNUMBER: 202404-26105

Report

Subject	Report
Inspection date/location	27.04.2024 Dick Automobile e.K., Ernst-Abbe-Str. 2, DE-36179 Bebra
Client	Dick Automobile e.K., Otto-Hahn-Str. 4-6, DE-36179 Bebra
Registration number	KN-DM93
Vehicle Identification Number	WAUZZZF50KA082231

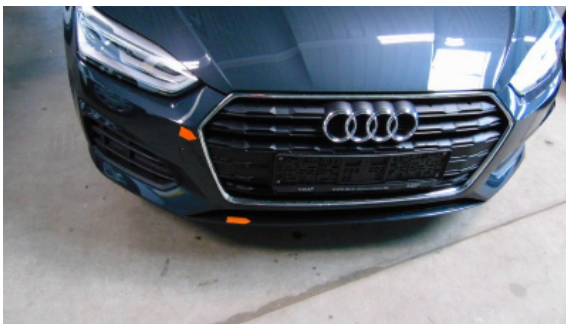
Image 1: Siehe Pos.1

Nr.	Component	Damage	Severity	Comment
1	Bumper front		Medium	
2	Bonnet	Stone chip	Slight	
3	Windshield	Stone chip	Medium	
4	Roof		Slight	
5	Door FL	Scratch	Slight	
6	Seat FL		Slight	
7	Tail light left	Scratch	Severe	
8	Door RR	Scratch	Severe	
9	Tailgate	Scratch	Severe	
10	Bumper rear		Slight
