REPORTNUMBER: 202403-25739

Report

Subject	Report
Inspection date/location	28.03.2024 Dick Automobile e.K., Ernst-Abbe-Str. 2, DE-36179 Bebra
Client	Dick Automobile e.K., Otto-Hahn-Str. 4-6, DE-36179 Bebra
Registration number	GT-HZ 1122
Vehicle Identification Number	W1N1671591A175821

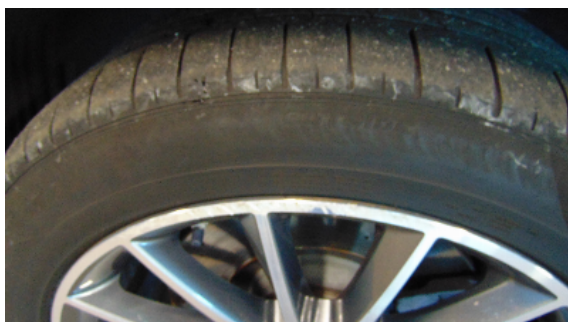
Image 1: siehe pos.1

Nr.	Component	Damage	Severity	Comment
1	Aluminium rim FL	Scratch	Medium	
2	Bonnet	Stone chip	Slight	
3	Bumper front	Stone chip	Slight	
4	Door FR	Scratch	Slight	
5	Door RR	Scratch	Slight	
6	Door RL	Scratch	Slight
