REPORTNUMBER: 202404-26039

Report

Subject	Report
Inspection date/location	22.04.2024 Dick Automobile e.K., Ernst-Abbe-Str. 2, DE-36179 Bebra
Client	Dick Automobile e.K., Otto-Hahn-Str. 4-6, DE-36179 Bebra
Registration number	ME-SP1286
Vehicle Identification Number	WAUZZZF4XJA228401

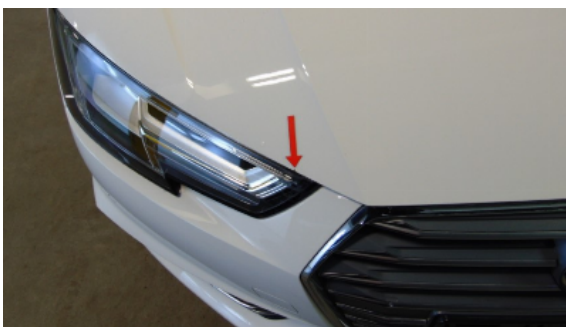
Image 1: Siehe Pos.1

Nr.	Component	Damage	Severity	Comment
1	Bonnet	Stone chip	Slight	
2	Bumper front	Stone chip	Slight	
3	Mirror cap left	Scratch	Slight	
4	Windshield	Stone chip	Slight	
5		Scratch	Severe	
6	Door panel FL	Scratch	Medium	
7	Side panel left	Scratch	Slight	
8	Tailgate	Scratch	Slight	
9			Severe	
10		Scratch	Slight	
11	Fender ri	Stone chip	Slight
