REPORTNUMBER: 202405-26182

Report

Subject	Report
Inspection date/location	04.05.2024 Dick Automobile e.K., Ernst-Abbe-Str. 2, DE-36179 Bebra
Client	Dick Automobile e.K., Otto-Hahn-Str. 4-6, DE-36179 Bebra
Registration number	BI-XX1110
Vehicle Identification Number	WDD2130341A486586

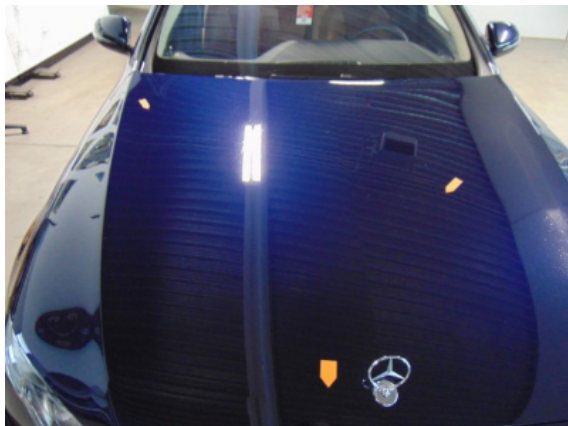
Image 1: Siehe Pos.1

Nr.	Component	Damage	Severity	Comment
1	Bonnet		Medium	
2	Windshield	Stone chip	Slight	
3	Door panel FL	Scratch	Slight	
4	Door RL	Scratch	Slight	
5	Door panel RR		Slight	
6	Tailgate		Medium
