Gerlach & Schröder GbR
Nürnberger Str. 34
DE-36199 Rotenburg a.d. Fulda/Lisp.

REPORTNUMBER: 202405-26156

Report

Subject	Report
Inspection date/location	02.05.2024 Dick Automobile e.K., Ernst-Abbe-Str. 2, DE-36179 Bebra
Client	Dick Automobile e.K., Otto-Hahn-Str. 4-6, DE-36179 Bebra
Registration number	K-LU 1988 E
Vehicle Identification Number	WDD2130161A719853

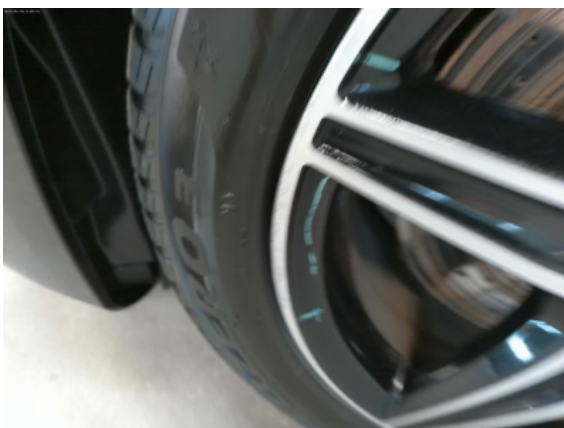
Image 1: Siehe Pos.1

Nr.	Component	Damage	Severity	Comment
1	Aluminium rim FL	Scratch	Slight	
2	Aluminium rim RL	Scratch	Slight	
3	Bonnet	Stone chip	Slight	
4	Bumper front		Slight	
5	Windshield	Stone chip	Slight	
6	Door FL	Scratch	Slight	
7	Door entry FL	Scratch	Slight	
8	Door entry RL	Scratch	Slight	
9	Bumper rear	Scratch	Medium	
10	Side panel right	Scratch	Slight	
11	Door entry RR	Scratch	Slight	
12	Door panel RR	Scratch	Slight

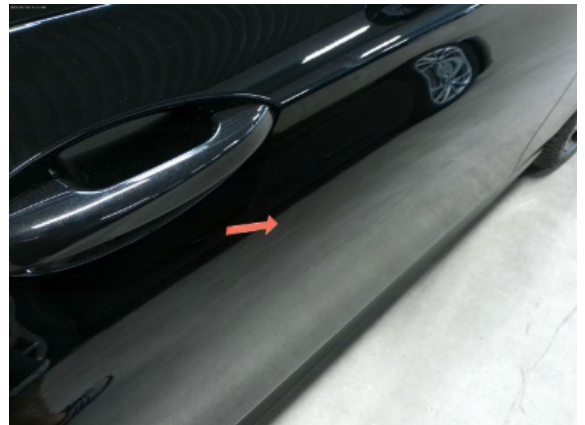
Image 12: Siehe Pos.13

13	Door FR	Dent	Slight
14	Door panel FR	Deformation	Slight
