REPORTNUMBER: 202403-25659

Report

Subject	Report
Inspection date/location	25.03.2024 Dick Automobile e.K., Ernst-Abbe-Str. 2, DE-36179 Bebra
Client	Dick Automobile e.K., Otto-Hahn-Str. 4-6, DE-36179 Bebra
Registration number	M-AT3883
Vehicle Identification Number	WBA8H710X0A725194

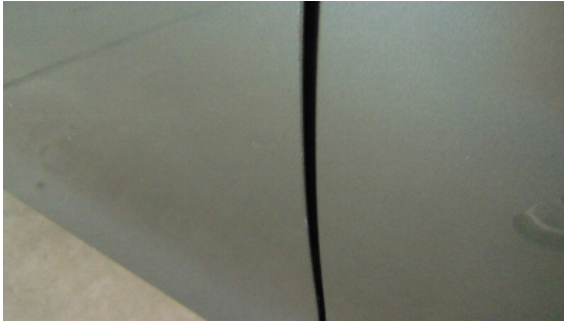
Image 5: siehe pos.5

Nr.	Component	Damage	Severity	Comment
1	Bonnet	Stone chip	Slight	
2	Bumper front	Stone chip	Slight	
3	Door RR		Slight	
4	Tailgate panel	Scratch	Slight	
5	Door FL	Scratch	Slight	
6	Roof	Dent	Slight
