REPORTNUMBER: 202404-25793

## Report

<b>Subject</b>	Report
<b>Inspection date/location</b>	04.04.2024   Dick Automobile e.K., Ernst-Abbe-Str. 2, DE-36179 Bebra
<b>Client</b>	Dick Automobile e.K., Otto-Hahn-Str. 4-6, DE-36179 Bebra
<b>Registration number</b>	NF-DK1081
<b>Vehicle Identification Number</b>	W1K2132121A849122

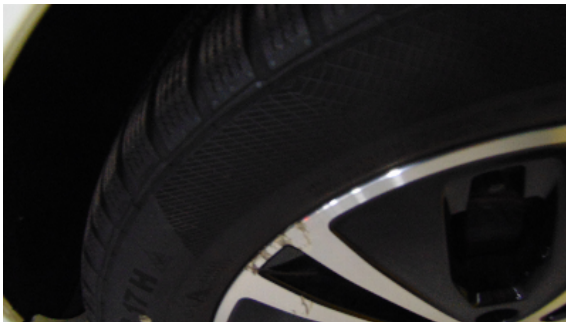
Image 1: siehe pos.1

Nr.	Component	Damage	Severity	Comment
1	Aluminium rim RL	Scratch	Medium	
2	Bonnet	Stone chip	Slight	
3	Bumper front	Stone chip	Slight	
4	Side panel left	Scratch	Slight

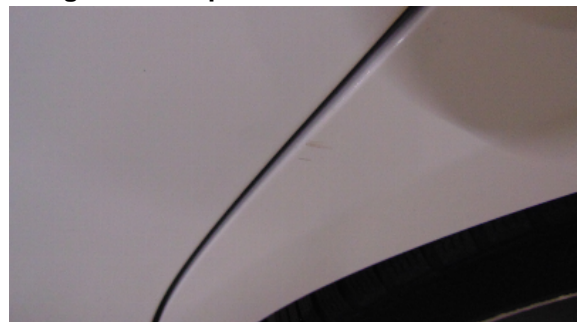
Image 4: siehe pos.4

- Side panel le.; ~ 190µm

A sample-like paint thickness measurement showed an increased paint thickness, which is almost certainly due to a repaired damage.
