REPORTNUMBER: 202404-25773

## Report

<b>Subject</b>	Report
<b>Inspection date/location</b>	03.04.2024   Dick Automobile e.K., Ernst-Abbe-Str. 2, DE-36179 Bebra
<b>Client</b>	Dick Automobile e.K., Otto-Hahn-Str. 4-6, DE-36179 Bebra
<b>Registration number</b>	PB-BA 9994
<b>Vehicle Identification Number</b>	WBAJN710X0BJ06549

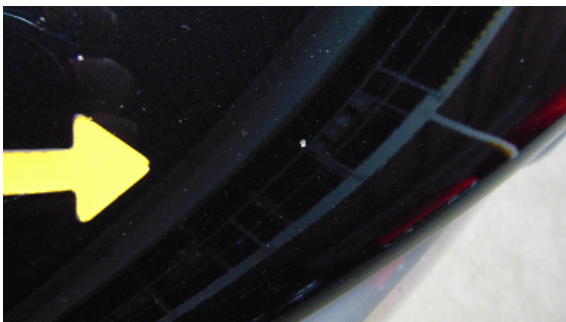
Image 1: siehe pos.1

Nr.	Component	Damage	Severity	Comment
1	Bonnet	Stone chip	Slight	
2	Door FR	Scratch	Slight	
3	Door RR	Scratch	Slight	
4	Tailgate panel	Scratch	Slight	
5	Bumper rear	Scratch	Slight	
6	Side panel left	Scratch	Slight	
7	Door RL	Scratch	Slight
