REPORTNUMBER: 202404-26092

## Report

<b>Subject</b>	Report
<b>Inspection date/location</b>	26.04.2024   Dick Automobile e.K., Ernst-Abbe-Str. 2, DE-36179 Bebra
<b>Client</b>	Dick Automobile e.K., Otto-Hahn-Str. 4-6, DE-36179 Bebra
<b>Registration number</b>	M-TR 2896
<b>Vehicle Identification Number</b>	WBAJT91060BR75439

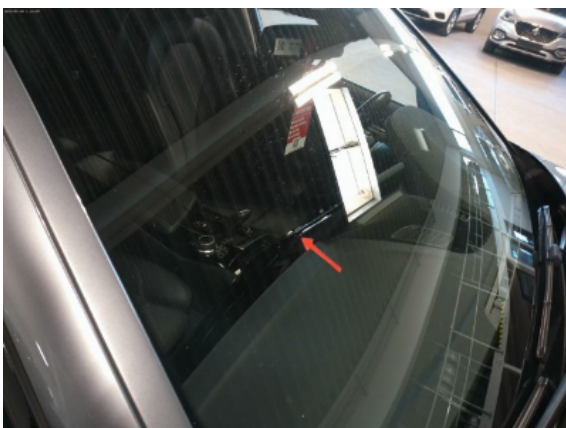
Image 1: Siehe Pos.1

Nr.	Component	Damage	Severity	Comment
1	Windshield	Stone chip	Slight	
2	Bonnet	Stone chip	Slight	
3	Bumper front	Stone chip	Slight	
4	Mirror cap left	Stone chip	Slight	
5	Door FL	Scratch	Severe	
6	Bumper rear	Scratch	Slight	
7	Door FR	Scratch	Medium	
8	Mirror cap right	Stone chip	Slight
