Report

| Registration number | M-J5437 |
| Vehicle Identification Number | WBAJT510X0BU75843 |

| Model / Sales description | 530i Tour.xDr.185 Aut.5d |

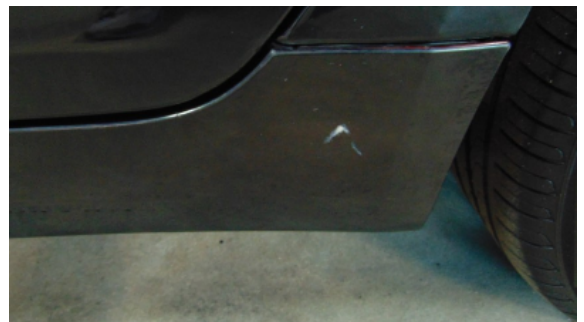
Image 2: Siehe Pos.2

| Nr. | Component | Damage | Severity | Comment |
|---|---|---|---|---|
| 2 | | Scratch | Slight | |

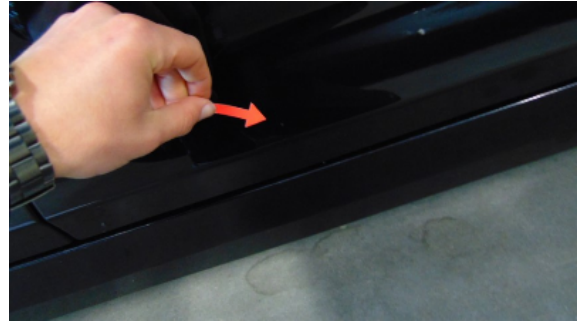
Image 4: Siehe Pos.4

| Nr. | Component | Damage | Severity | Comment |
|---|---|---|---|---|
| 4 | Door FR | Scratch | Slight | |
