REPORTNUMBER: 202501-29195

Report

Subject	Report
Inspection date/location	28.01.2025 Dick Automobile e.K., Ernst-Abbe-Str. 2, DE-36179 Bebra
Client	Dick Automobile e.K., Otto-Hahn-Str. 4-6, DE-36179 Bebra
Registration number	GI-TB300
Vehicle Identification Number	WVWZZZ3CZLE143445

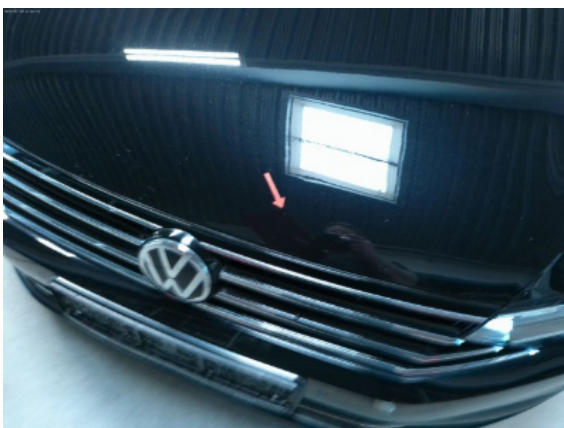
Image 1: Siehe Pos.1

Nr.	Component	Damage	Severity	Comment
1	Bonnet	Stone chip	Slight	
2	Bumper front	Stone chip	Slight	
3	Mirror cap left	Stone chip	Slight	
4	Bumper rear	Scratch	Slight	
5	Side panel right	Dent	Slight	
6	Mirror cap right	Crack	Severe
