Gerlach & Schröder GbR
Nürnberger Str. 34
DE-36199 Rotenburg a.d. Fulda/Lisp.

REPORTNUMBER: 202404-25869

Report

Subject	Report
Inspection date/location	10.04.2024 Dick Automobile e.K., Ernst-Abbe-Str. 2, DE-36179 Bebra
Client	Dick Automobile e.K., Otto-Hahn-Str. 4-6, DE-36179 Bebra
Registration number	FN-RR 442 E
Vehicle Identification Number	W1N2533531F916091

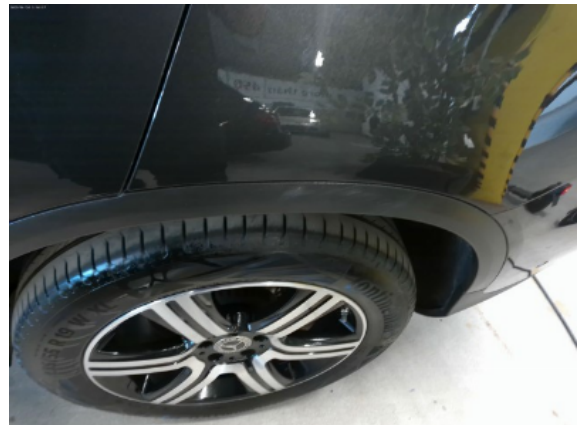
Image 6: Siehe Pos.5

Nr.	Component	Damage	Severity	Comment
1	Windshield	Stone chip	Slight	
2	Bonnet	Stone chip	Slight	
3	Bumper front	Stone chip	Slight	
4	Mirror cap left	Stone chip	Slight	
5	Side panel left	Scratch	Slight	
6	Bumper rear	Scratch	Slight	
7	Door RR	Scratch	Slight	
8	Mirror cap right	Stone chip	Slight

- Side panel le.; ~ 210µm

A sample-like paint thickness measurement showed an increased paint thickness, which is almost certainly due to a repaired damage.
