Gerlach & Schröder GbR
Nürnberger Str. 34
DE-36199 Rotenburg a.d. Fulda/Lisp.

REPORTNUMBER: 202401-24985

Report

Subject	Report
Inspection date/location	29.01.2024 Dick Automobile e.K., Ernst-Abbe-Str. 2, DE-36179 Bebra
Client	Dick Automobile e.K., Otto-Hahn-Str. 4-6, DE-36179 Bebra
Registration number	AB-MA 404
Vehicle Identification Number	WDD2052831F950466

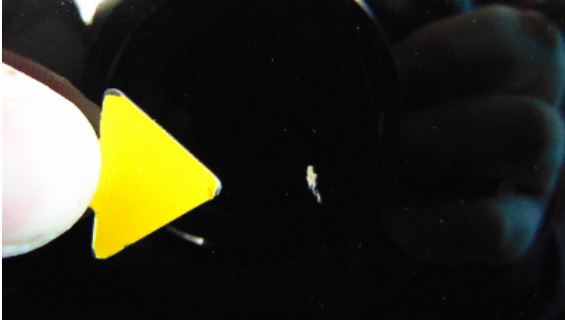
Image 1: siehe pos.1

Nr.	Component	Damage	Severity	Comment
1	Bonnet	Stone chip	Slight	
2	Bumper front	Stone chip	Slight	
3	Fender ri	Stone chip	Slight	
4	Door RR	Scratch	Slight	
5	Tailgate	Scratch	Slight	
6	Tailgate panel	Scratch	Slight	
7	Bumper rear	Scratch	Slight	
8	Door RL	Scratch	Slight
