REPORTNUMBER: 202404-26022

## Report

<b>Subject</b>	Report
<b>Inspection date/location</b>	22.04.2024   Dick Automobile e.K., Ernst-Abbe-Str. 2, DE-36179 Bebra
<b>Client</b>	Dick Automobile e.K., Otto-Hahn-Str. 4-6, DE-36179 Bebra
<b>Registration number</b>	M-J1063
<b>Vehicle Identification Number</b>	WBA6L71030FJ11919

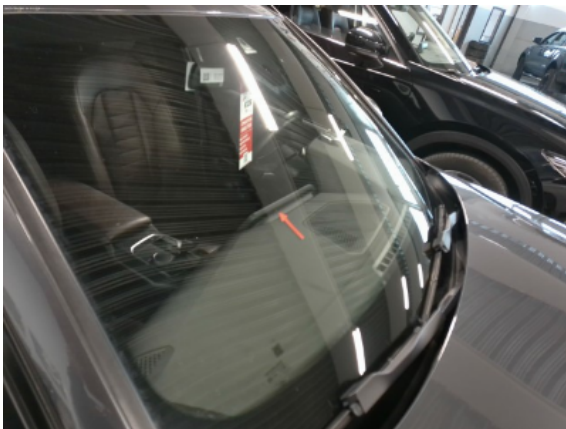
Image 1: Siehe Pos.1

Nr.	Component	Damage	Severity	Comment
1	Windshield	Stone chip	Slight	
2	Bonnet	Scratch	Slight	
3	Bonnet	Stone chip	Slight	
4	Bumper front	Stone chip	Slight	
5	Mirror cap left	Stone chip	Slight	
6	Door FL	Scratch	Slight	
7	Door RL	Scratch	Slight	
8	Bumper rear	Scratch	Slight	
9	Fender ri	Scratch	Slight
