REPORTNUMBER: 202404-26003

Report

Subject	Report
Inspection date/location	19.04.2024 Dick Automobile e.K., Ernst-Abbe-Str. 2, DE-36179 Bebra
Client	Dick Automobile e.K., Otto-Hahn-Str. 4-6, DE-36179 Bebra
Registration number	HH-UL6200
Vehicle Identification Number	WBA6L51000FJ38256

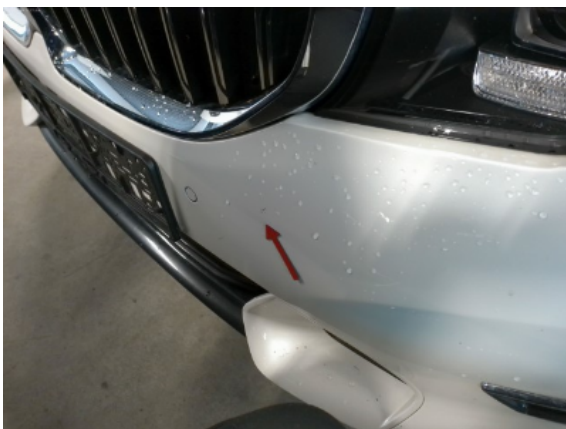
Image 1: Siehe Pos.1

Nr.	Component	Damage	Severity	Comment
1	Bumper front	Stone chip	Slight	
2	Side panel left	Dent	Slight	
3	Bumper rear	Scratch	Slight	
4	Door FR	Stone chip	Slight	
5	Fender ri	Stone chip	Slight	
6	Aluminium rim FR	Scratch	Medium
