REPORTNUMBER: 202403-25590

Report

Subject	Report
Inspection date/location	19.03.2024 Dick Automobile e.K., Ernst-Abbe-Str. 2, DE-36179 Bebra
Client	Dick Automobile e.K., Otto-Hahn-Str. 4-6, DE-36179 Bebra
Registration number	E-SD 554
Vehicle Identification Number	WBA6L31020FK22874

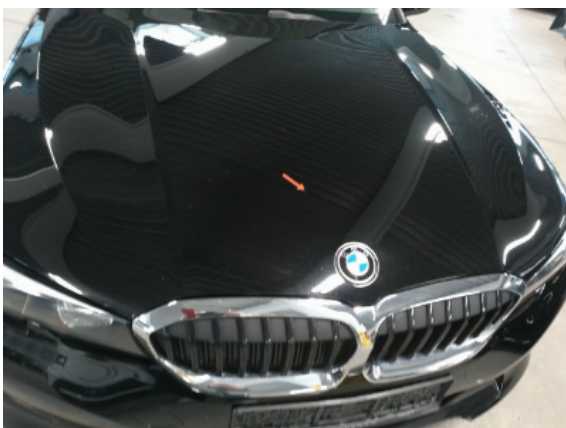
Image 1: Siehe Pos.1

Nr.	Component	Damage	Severity	Comment
1	Bonnet	Stone chip	Slight	
2	Bumper front	Stone chip	Slight	
3	Fender le	Stone chip	Slight	
4	Mirror cap left	Stone chip	Slight	
5	Door FL	Scratch	Slight	
6	Bumper rear	Scratch	Slight	
7	Door FR	Scratch	Slight	
8	Mirror cap right	Stone chip	Slight	
9	Fender ri	Scratch	Slight
