REPORTNUMBER: 202408-27370

## Report

<b>Subject</b>	Report
<b>Inspection date/location</b>	24.08.2024   Dick Automobile e.K., Ernst-Abbe-Str. 2, DE-36179 Bebra
<b>Client</b>	Dick Automobile e.K., Otto-Hahn-Str. 4-6, DE-36179 Bebra
<b>Registration number</b>	DA-IT 125 E
<b>Vehicle Identification Number</b>	WBA6N71000FL07441

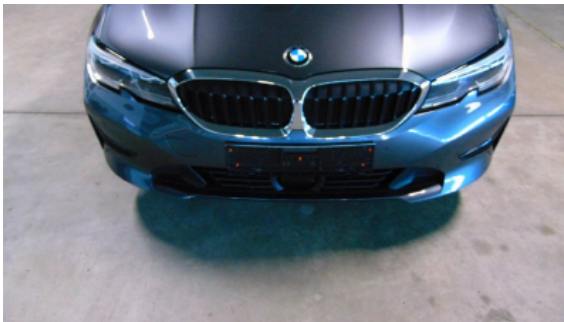
Image 1: Siehe Pos.1

Nr.	Component	Damage	Severity	Comment
1	Bumper front	Stone chip	Slight	
2	Bonnet	Stone chip	Slight	
3	Door FL		Medium	
4	Tail light left		Slight	
5	Aluminium rim RL		Medium	
6	Bumper rear		Slight
