REPORTNUMBER: 202409-27605

Report

Subject	Report
Inspection date/location	13.09.2024 Dick Automobile e.K., Ernst-Abbe-Str. 2, DE-36179 Bebra
Client	Dick Automobile e.K., Otto-Hahn-Str. 4-6, DE-36179 Bebra
Registration number	M-TR5609
Vehicle Identification Number	W0VBD6EV2LG040151

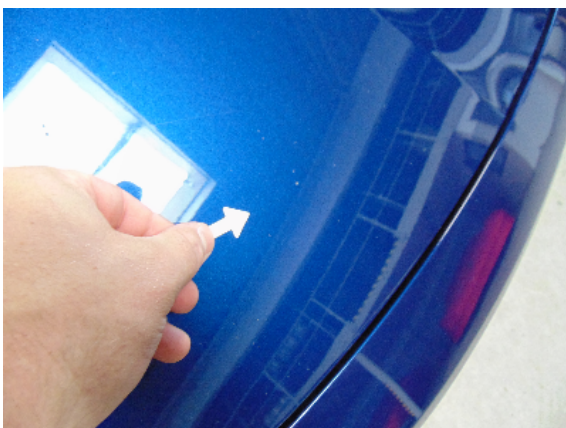
Image 1: siehe pos.1

Nr.	Component	Damage	Severity	Comment
1	Bonnet	Stone chip	Slight	
2	Bumper front	Stone chip	Slight	
3	Side panel right	Dent	Slight	
4	Bumper rear	Scratch	Slight	
5	Door FL	Scratch	Slight
