Gerlach & Schröder GbR  
Nürnberger Str. 34  
DE-36199 Rotenburg a.d. Fulda/Lisp.

REPORTNUMBER: 202401-24707

## Report

| <b>Model / Sales description</b> | A 200d AMG Line 110 Aut.5d |

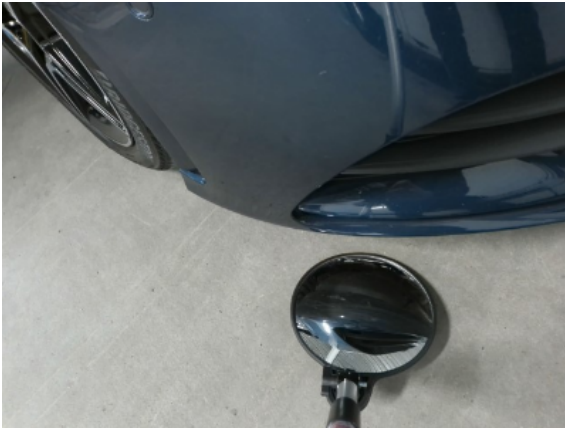
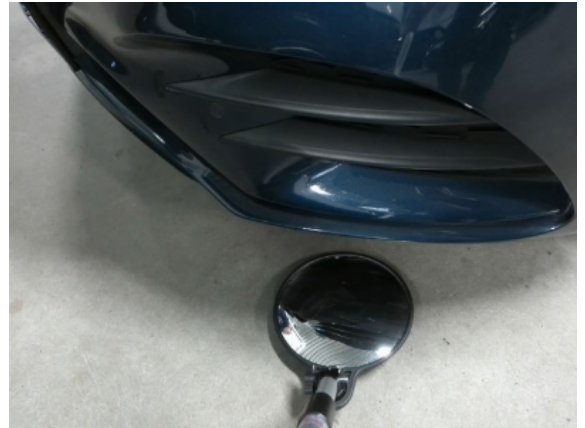
Image 1: Siehe Pos.1

| Nr. | Component | Damage | Severity | Comment |
|---|---|---|---|---|
| 1 | Bumper front | | Medium | |

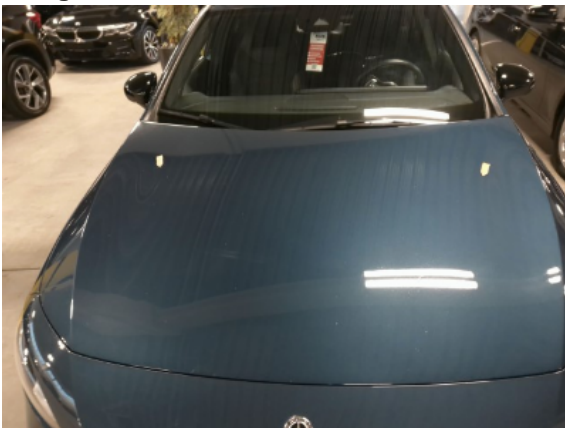
Image 3: Siehe Pos.2

| Nr. | Component | Damage | Severity | Comment |
|---|---|---|---|---|
| 2 | Bonnet | | Slight | |

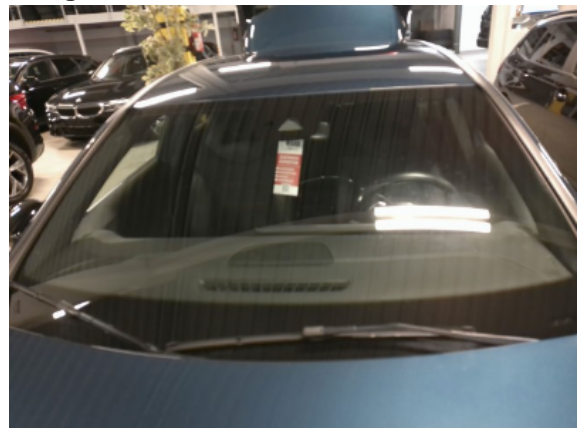
Image 4: Siehe Pos.3

| Nr. | Component | Damage | Severity | Comment |
|---|---|---|---|---|
| 3 | Windshield | | Severe | |

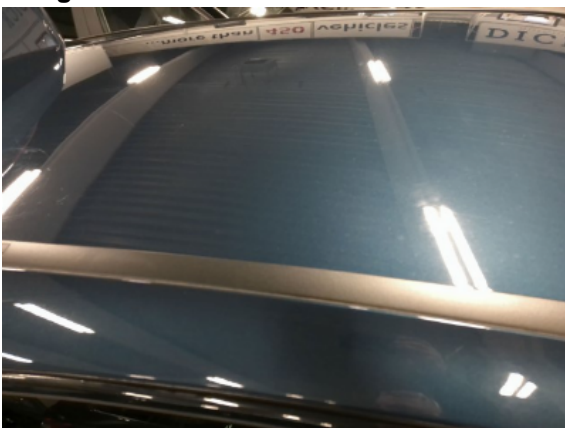
Image 5: Siehe Pos.4

| Nr. | Component | Damage | Severity | Comment |
|---|---|---|---|---|
| 4 | Roof | Scratch | Slight | |

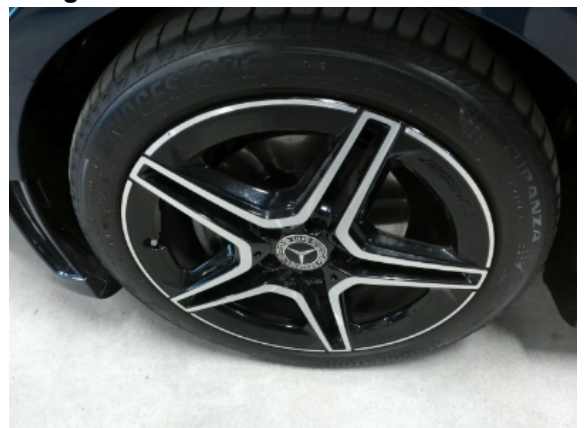
Image 6: Siehe Pos.5

| Nr. | Component | Damage | Severity | Comment |
|---|---|---|---|---|
| 5 | Aluminium rim FL | | Slight | |

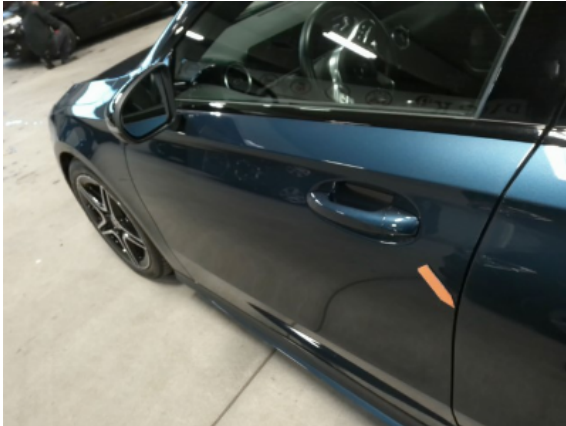
Image 7: Siehe Pos.6

| Nr. | Component | Damage | Severity | Comment |
|---|---|---|---|---|
| 6 | Door FL | | Slight | |

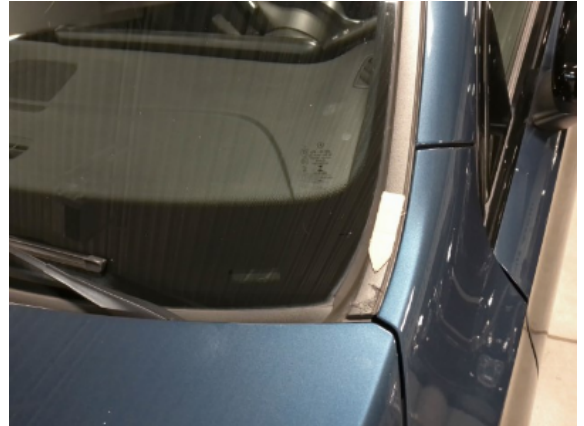
Image 8: Siehe Pos.7

| Nr. | Component | Damage | Severity | Comment |
|---|---|---|---|---|
| 7 | | | Severe | |

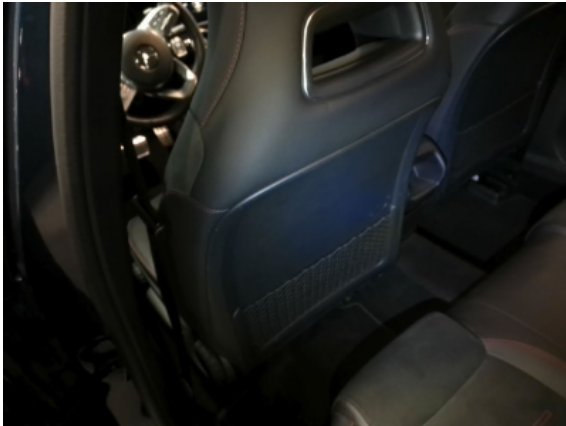
Image 9: Siehe Pos.8

| Nr. | Component | Damage | Severity | Comment |
|---|---|---|---|---|
| 8 | Seat FL | | Slight | |

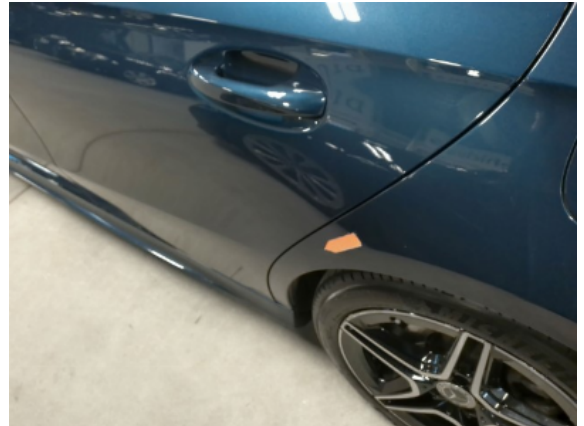
Image 10: Siehe Pos.9

| Nr. | Component | Damage | Severity | Comment |
|---|---|---|---|---|
| 9 | Side panel left | Stone chip | Slight | |

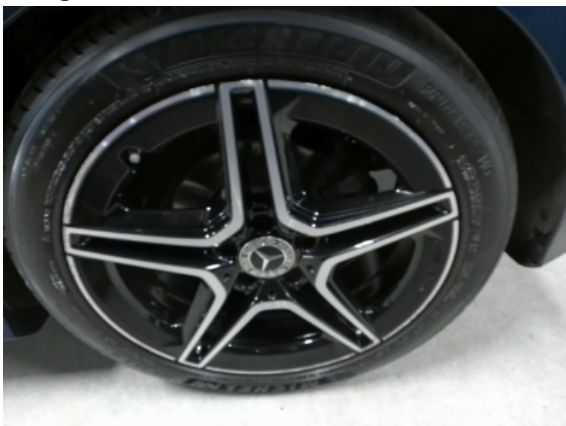
Image 11: Siehe Pos.10

| Nr. | Component | Damage | Severity | Comment |
|---|---|---|---|---|
| 10 | Aluminium rim RL | | Medium | |

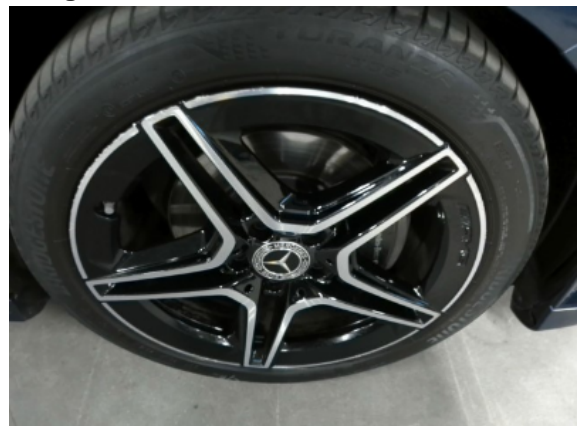
Image 12: Siehe Pos.11

| Nr. | Component | Damage | Severity | Comment |
|---|---|---|---|---|
| 11 | Aluminium rim FR | | Medium | |

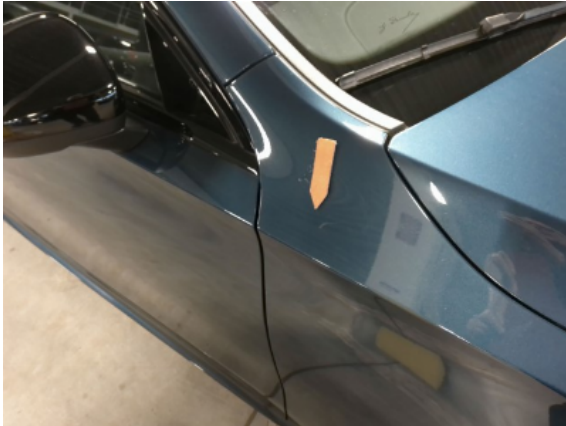
Image 13: Siehe Pos.12

| Nr. | Component | Damage | Severity | Comment |
|---|---|---|---|---|
| 12 | Fender ri | Scratch | Medium | |

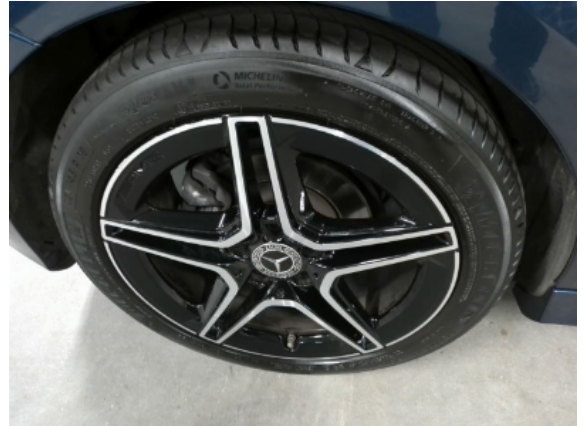
Image 14: Siehe Pos.13

| 13 | Aluminium rim RR | Medium |

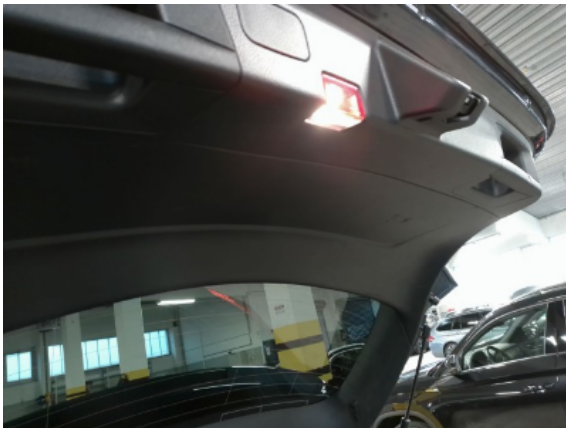
Image 15: Siehe Pos.14

| 14 | Tailgate panel | Slight |
