REPORTNUMBER: 202404-25963

Report

Subject	Report
Inspection date/location	17.04.2024 Dick Automobile e.K., Ernst-Abbe-Str. 2, DE-36179 Bebra
Client	Dick Automobile e.K., Otto-Hahn-Str. 4-6, DE-36179 Bebra
Registration number	K-RI771
Vehicle Identification Number	W0VECYHZJLJ530739

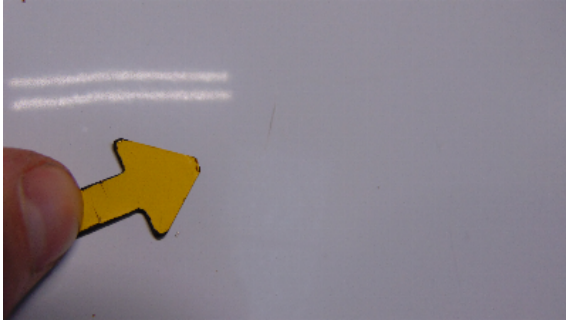
Image 1: siehe pos.1

Nr.	Component	Damage	Severity	Comment
1	Bonnet	Scratch	Slight	
2	Bumper front	Scratch	Medium	
3	Fender ri		Medium	
4	Door FR	Scratch	Slight	
5	Bumper rear	Scratch	Slight	
6	Side panel left	Scratch	Slight	
7	Door RL	Scratch	Slight	
8	Mirror cap left	Scratch	Slight	
9	Fender le		Medium
