REPORTNUMBER: 202404-26101

## Report

<b>Subject</b>	Report
<b>Inspection date/location</b>	26.04.2024   Dick Automobile e.K., Ernst-Abbe-Str. 2, DE-36179 Bebra
<b>Client</b>	Dick Automobile e.K., Otto-Hahn-Str. 4-6, DE-36179 Bebra
<b>Registration number</b>	OD-MK765
<b>Vehicle Identification Number</b>	VF73EEHYRKJ591151

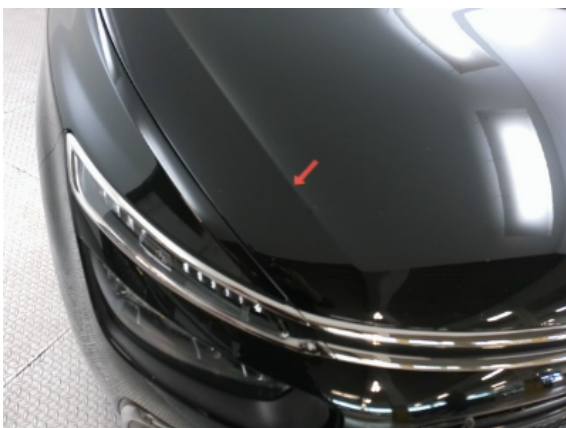
Image 1: Siehe Pos.1

Nr.	Component	Damage	Severity	Comment
1	Bonnet	Stone chip	Severe	
2	Bumper front	Stone chip	Slight	
3	Bumper rear		Medium	
4	Tailgate panel	Scratch	Severe	
5	Mirror cap right	Stone chip	Slight	
6	Fender ri	Stone chip	Slight
