REPORTNUMBER: 202404-26066

Report

Subject	Report
Inspection date/location	24.04.2024 Dick Automobile e.K., Ernst-Abbe-Str. 2, DE-36179 Bebra
Client	Dick Automobile e.K., Otto-Hahn-Str. 4-6, DE-36179 Bebra
Registration number	B-PS 981
Vehicle Identification Number	WF0SXXWPGSJJ09805

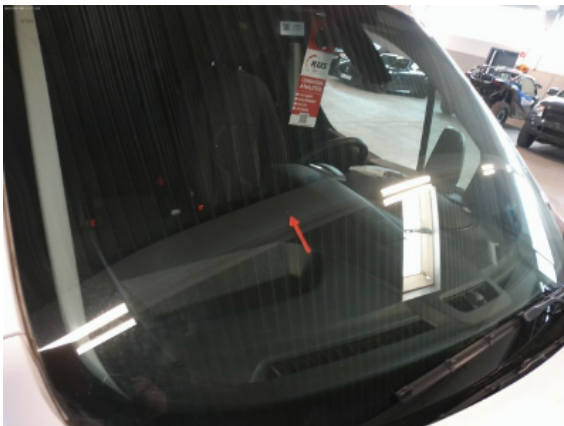
Image 1: Siehe Pos.1

Nr.	Component	Damage	Severity	Comment
1	Windshield	Stone chip	Slight	
2	Bonnet	Stone chip	Slight	
3	Bumper front	Scratch	Severe	
4	Fender le	Scratch	Severe	
5	Door FL	Scratch	Slight	
6	Side panel left	Scratch	Medium	
7	Bumper rear		Medium	
8	Bumper rear	Scratch	Slight	
9	Tailgate	Scratch	Slight	
10	Door RR	Scratch	Slight	
11		Scratch	Slight	
12	Door FR	Scratch	Slight

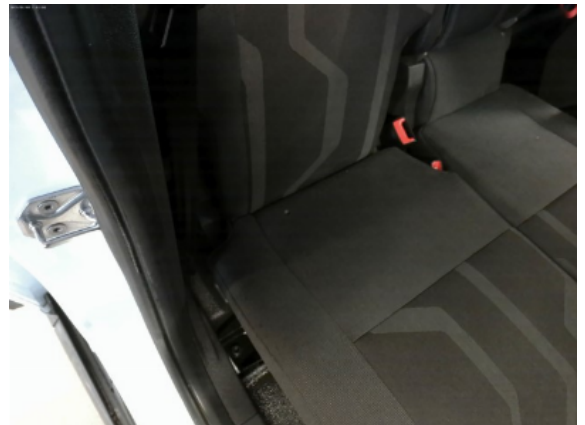
Image 14: Siehe Pos.13

13 Seat FR

Burn hole

Severe
