REPORTNUMBER: 202404-26094

Report

Subject	Report
Inspection date/location	26.04.2024 Dick Automobile e.K., Ernst-Abbe-Str. 2, DE-36179 Bebra
Client	Dick Automobile e.K., Otto-Hahn-Str. 4-6, DE-36179 Bebra
Registration number	SG-GE 1050
Vehicle Identification Number	WF0FXXWPCFJM86563

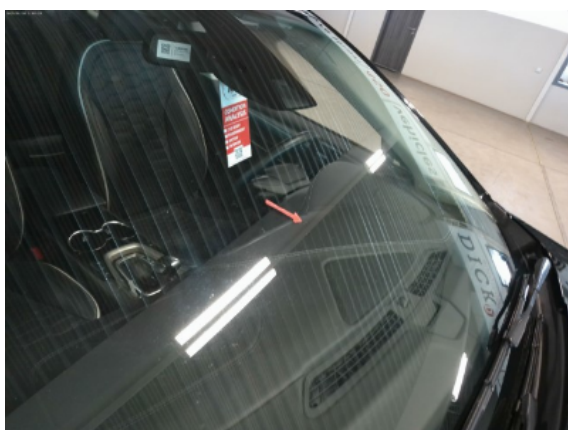
Image 1: Siehe Pos.1

Nr.	Component	Damage	Severity	Comment
1	Windshield	Stone chip	Slight	
2	Bonnet	Stone chip	Severe	
3	Bumper front	Stone chip	Severe	
4	Fender le	Stone chip	Medium	
5	Mirror cap left	Stone chip	Slight	
6	Door entry FL	Scratch	Slight	
7	Door RL	Scratch	Slight	
8	Bumper rear	Scratch	Slight	
9	Tailgate	Scratch	Severe	
10	Mirror cap right	Stone chip	Slight	
11	Fender ri	Stone chip	Slight	
12	Roof	Stone chip	Slight
