REPORTNUMBER: 202403-25557

Report

Subject	Report
Inspection date/location	15.03.2024 Dick Automobile e.K., Ernst-Abbe-Str. 2, DE-36179 Bebra
Client	Dick Automobile e.K., Otto-Hahn-Str. 4-6, DE-36179 Bebra
Registration number	ERB-DC 47
Vehicle Identification Number	WF0FXXWPCFJP20510

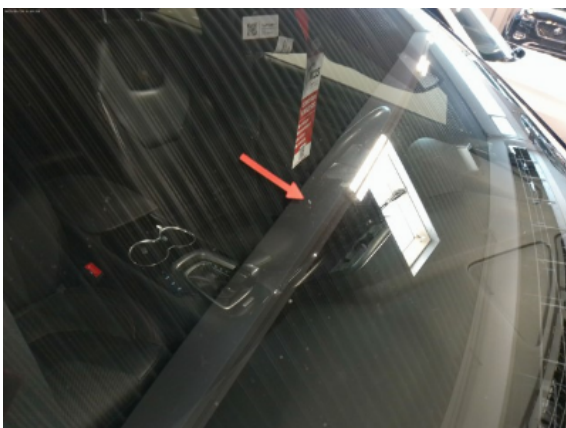
Image 1: Siehe Pos.1

Nr.	Component	Damage	Severity	Comment
1	Windshield	Stone chip	Slight	
2	Bonnet	Stone chip	Slight	
3	Bumper front	Stone chip	Slight	
4	Bumper front	Scratch	Slight	
5	Mirror cap left	Stone chip	Slight	
6	Door FL	Scratch	Slight	
7	Door RL	Scratch	Slight	
8	Bumper rear	Scratch	Slight	
9	Tailgate	Scratch	Slight	
10	Mirror cap right	Stone chip	Slight	
11	Fender ri	Stone chip	Slight
