REPORTNUMBER: 202404-26096

## Report

<b>Subject</b>	Report
<b>Inspection date/location</b>	26.04.2024   Dick Automobile e.K., Ernst-Abbe-Str. 2, DE-36179 Bebra
<b>Client</b>	Dick Automobile e.K., Otto-Hahn-Str. 4-6, DE-36179 Bebra
<b>Registration number</b>	B-EA2969
<b>Vehicle Identification Number</b>	WF0YXXTTGYJR46009

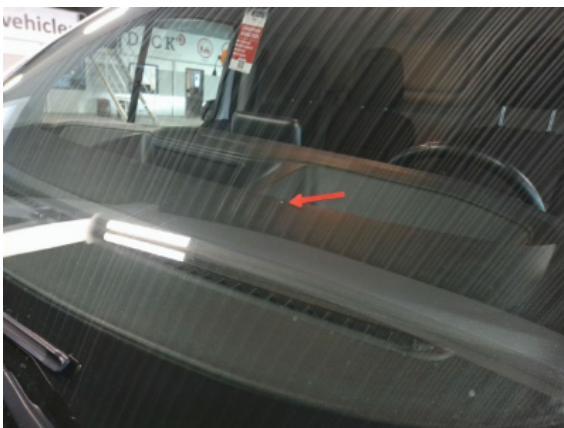
Image 1: Siehe Pos.1

Nr.	Component	Damage	Severity	Comment
1	Windshield	Stone chip	Slight	
2	Bonnet	Stone chip	Slight	
3	Mirror cap left	Stone chip	Slight	
4	Door FL	Scratch	Slight	
5	Tailgate	Scratch	Slight	
6	Door RR	Dent	Slight	
7	Door RR	Scratch	Severe	
8	Door FR	Scratch	Slight	
9	Bonnet	Dent	Slight
