Gerlach & Schröder GbR  
Nürnberger Str. 34  
DE-36199 Rotenburg a.d. Fulda/Lisp.

REPORTNUMBER: 202404-25786

<b>Subject</b>	Report
<b>Inspection date/location</b>	03.04.2024   Dick Automobile e.K., Ernst-Abbe-Str. 2, DE-36179 Bebra
<b>Client</b>	Dick Automobile e.K., Otto-Hahn-Str. 4-6, DE-36179 Bebra
<b>Registration number</b>	AÖ-S 3008
<b>Vehicle Identification Number</b>	WF0YXXTTGYKC39673

<b>Subject</b>	Report
<b>Client</b>	Dick Automobile e.K., Otto-Hahn-Str. 4-6, DE-36179 Bebra
<b>Inspection date/location</b>	03.04.2024   Dick Automobile e.K., Ernst-Abbe-Str. 2, DE-36179 Bebra
<b>Registration number</b>	AÖ-S 3008
<b>Vehicle type</b>	Minivan/Minibus
<b>Manufacturer</b>	Ford
<b>Model / Sales description</b>	Transit Custom
<b>Key numbers HSN/TSN</b>	8566 / BMV
<b>Vehicle identification number</b>	WF0YXXTTGYKC39673
<b>Previous owners</b>	1
<b>First registration</b>	17.04.2019
<b>Mileage</b>	207.254 km
<b>Colour / Colour Code</b>	
<b>Fuel Type</b>	Diesel
<b>Cubic Capacity / Power</b>	1.995 cm <sup>3</sup> / 125 kW
<b>Number of doors / seats</b>	4 / 3
<b>Transmission</b>	Automatic transmission
<b>Number of keys</b>	2
<b>Last maintenance</b>	14.04.2023 / 198.065 km
<b>Next vehicle

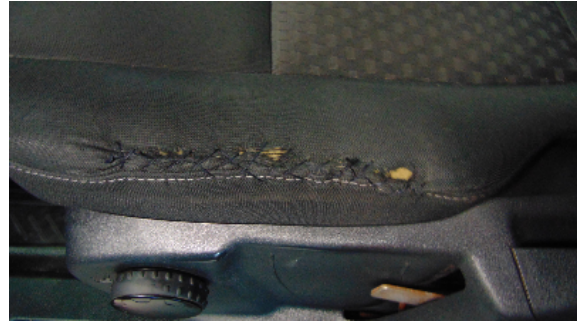
Image 14: siehe pos.14

14 Seat FL

Crack

Medium
