REPORTNUMBER: 202403-25719

## Report

<b>Subject</b>	Report
<b>Inspection date/location</b>	27.03.2024   Dick Automobile e.K., Ernst-Abbe-Str. 2, DE-36179 Bebra
<b>Client</b>	Dick Automobile e.K., Otto-Hahn-Str. 4-6, DE-36179 Bebra
<b>Registration number</b>	AÖ-S 3018
<b>Vehicle Identification Number</b>	WF0YXXTTGYKC39675

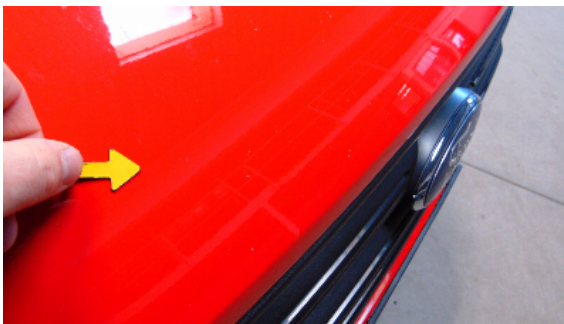
Image 1: siehe pos.1

Nr.	Component	Damage	Severity	Comment
1	Bonnet	Stone chip	Slight	
2	Bumper front	Stone chip	Slight	
3	Mirror cap right	Scratch	Slight	
4	Door FR	Scratch	Slight	
5	Bumper rear	Scratch	Medium	
6	Tailgate	Scratch	Slight	
7	Tailgate panel	Scratch	Slight	
8	Door FL	Scratch	Slight	
9	Seat FL	Scratch	Slight	
10	Mirror cap left	Scratch	Slight
