REPORTNUMBER: 202404-26019

Report

Subject	Report
Inspection date/location	20.04.2024 Dick Automobile e.K., Ernst-Abbe-Str. 2, DE-36179 Bebra
Client	Dick Automobile e.K., Otto-Hahn-Str. 4-6, DE-36179 Bebra
Registration number	B-EQ1517
Vehicle Identification Number	WF0RXXWPGRKJ59602

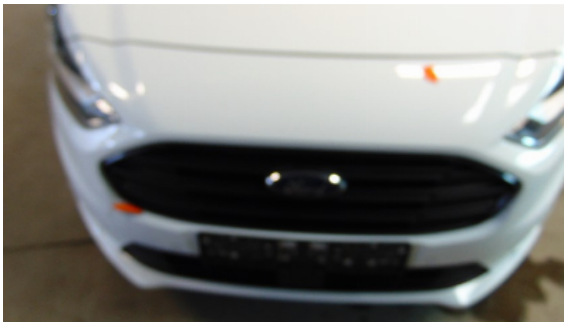
Image 1: Siehe Pos.1

Nr.	Component	Damage	Severity	Comment
1	Bumper front	Stone chip	Slight	
2	Bonnet	Stone chip	Slight	
3	Windshield	Stone chip	Medium	
4	Side panel left		Slight	
5	Fender ri		Slight	
6	Door RR		Slight	
7	Side panel right
