REPORTNUMBER: 202404-26006

Report

Subject	Report
Inspection date/location	19.04.2024 Dick Automobile e.K., Ernst-Abbe-Str. 2, DE-36179 Bebra
Client	Dick Automobile e.K., Otto-Hahn-Str. 4-6, DE-36179 Bebra
Registration number	F-S3190
Vehicle Identification Number	WF0NXXGCHNKU46859

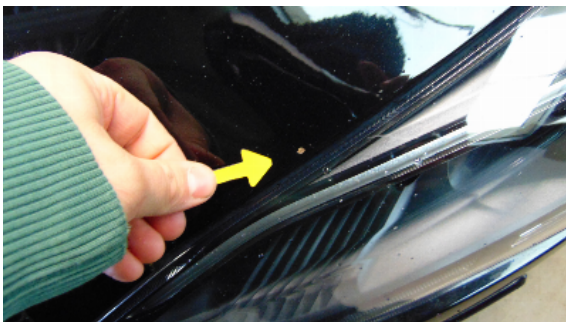
Image 1: siehe pos.1

Nr.	Component	Damage	Severity	Comment
1	Bonnet	Stone chip	Slight	
2	Bumper front	Stone chip	Slight	
3	Door RR	Scratch	Slight	
4	Tailgate panel		Severe	
5	Bumper rear	Scratch	Slight	
6	Aluminium rim FR	Paint chipping	Medium	
7	Aluminium rim RR	Paint chipping	Medium	
8	Aluminium rim FL	Paint chipping	Medium
