REPORTNUMBER: 202403-25708

Report

Subject	Report
Inspection date/location	27.03.2024 Dick Automobile e.K., Ernst-Abbe-Str. 2, DE-36179 Bebra
Client	Dick Automobile e.K., Otto-Hahn-Str. 4-6, DE-36179 Bebra
Registration number	M-HQ441
Vehicle Identification Number	WBATR51050LF97062

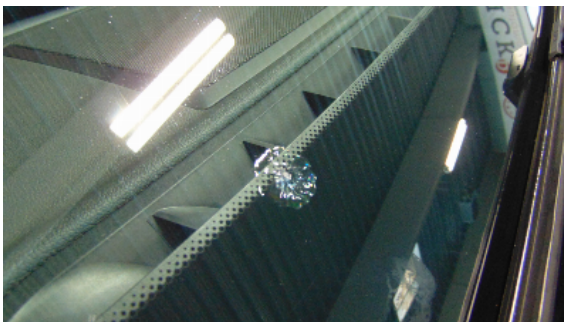
Image 1: siehe pos.1

Nr.	Component	Damage	Severity	Comment
1	Windshield	Stone chip	Medium	
2	Bonnet	Stone chip	Slight	
3	Bumper front	Stone chip	Slight	
4	Door entry RR	Scratch	Slight	
5	Bumper rear	Scratch	Slight	
6	Tailgate	Scratch	Slight	
7	Door RL	Scratch	Slight	
8	Fender le	Stone chip	Slight
