REPORTNUMBER: 202405-26234

Report

Subject	Report
Inspection date/location	08.05.2024 Dick Automobile e.K., Ernst-Abbe-Str. 2, DE-36179 Bebra
Client	Dick Automobile e.K., Otto-Hahn-Str. 4-6, DE-36179 Bebra
Registration number	H-OY745
Vehicle Identification Number	WBAUJ11000LG47726

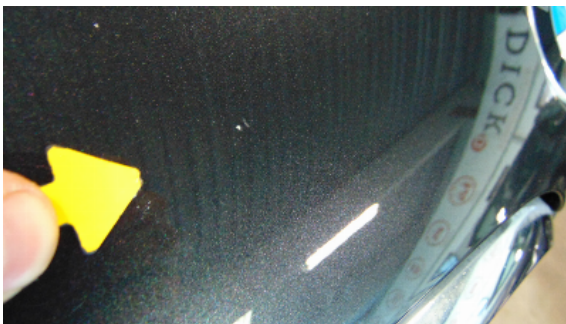
Image 1: siehe pos.1

Nr.	Component	Damage	Severity	Comment
1		Stone chip	Slight	
2	Bumper front	Stone chip	Slight	
3	Door RR	Scratch	Slight	
4	Side panel right	Scratch	Slight	
5	Tailgate	Scratch	Slight	
6	Bumper rear	Scratch	Slight	
7	Door entry RL	Scratch	Slight	
8	Door RL	Scratch	Slight	
9	Door FL	Scratch	Slight
