REPORTNUMBER: 202409-27527

Report

Subject	Report
Inspection date/location	06.09.2024 Dick Automobile e.K., Ernst-Abbe-Str. 2, DE-36179 Bebra
Client	Dick Automobile e.K., Otto-Hahn-Str. 4-6, DE-36179 Bebra
Registration number	M-HZ 2285E
Vehicle Identification Number	LSJA24393NN022583

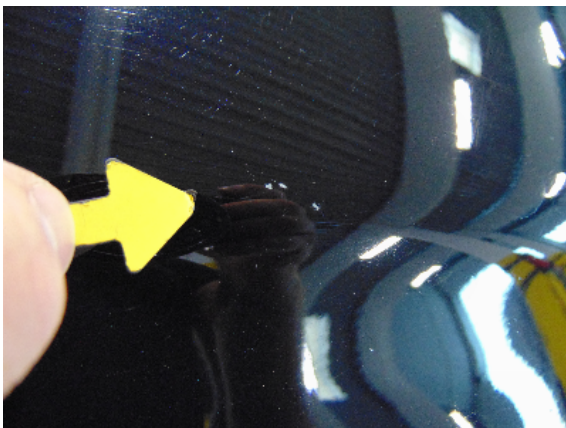
Image 1: siehe pos.1

Nr.	Component	Damage	Severity	Comment
1	Bonnet	Stone chip	Slight	
2	Bumper front	Stone chip	Slight	
3	Door FR	Scratch	Slight	
4	Bumper rear	Scratch	Slight	
5	Side panel left	Dent	Slight	
6	Door FL	Scratch	Slight	
7	Mirror cap left		Severe
