REPORTNUMBER: 202409-27526

Report

| Registration number | M-HZ3441E |

| Model / Sales description | EHS PHEV Luxury |

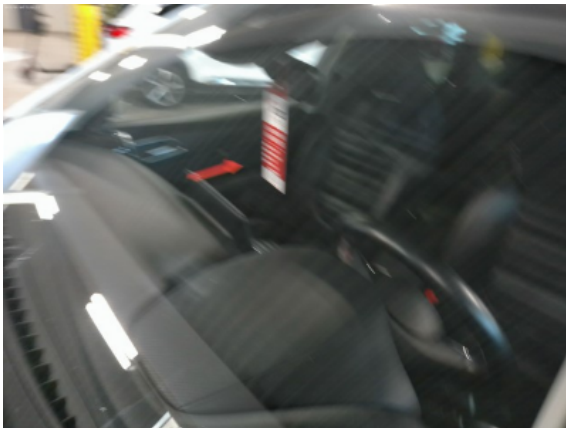
Image 1: Siehe Pos.1

| Nr. | Component | Damage | Severity | Comment |
|---|---|---|---|---|
| 1 | Windshield | Stone chip | Slight | |

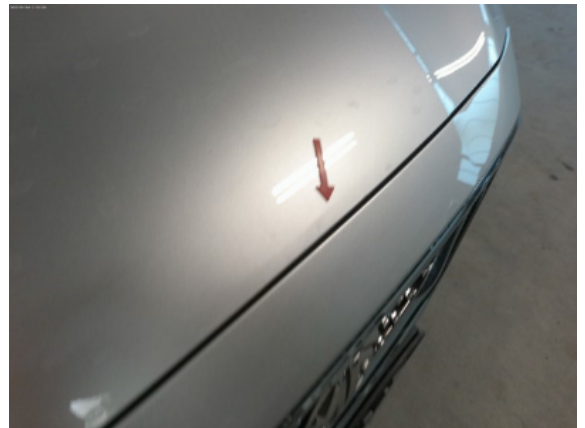
Image 2: Siehe Pos.2

| Nr. | Component | Damage | Severity | Comment |
|---|---|---|---|---|
| 2 | Bonnet | Deformation | Slight | |

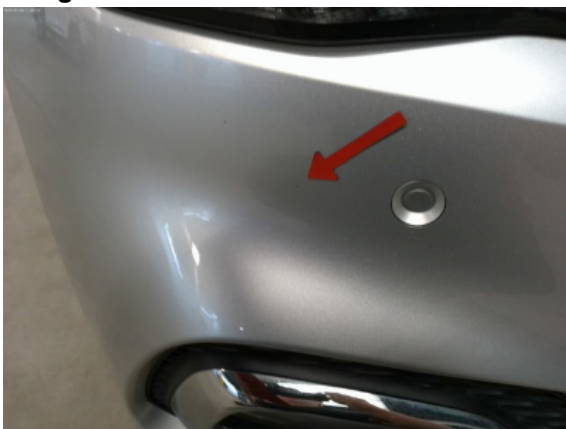
Image 3: Siehe Pos.3

| Nr. | Component | Damage | Severity | Comment |
|---|---|---|---|---|
| 3 | Bumper front | Stone chip | Slight | |

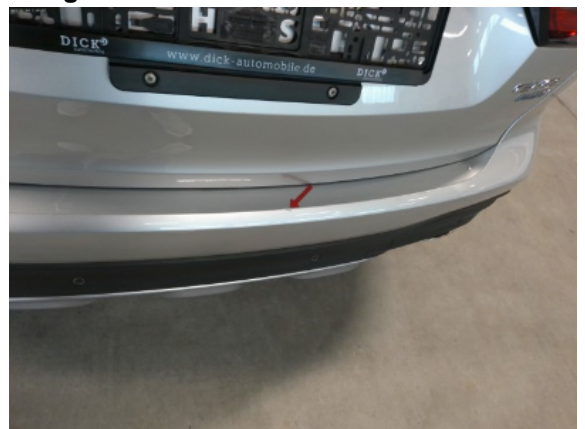
Image 4: Siehe Pos.4

| Nr. | Component | Damage | Severity | Comment |
|---|---|---|---|---|
| 4 | Bumper rear | Scratch | Medium | |

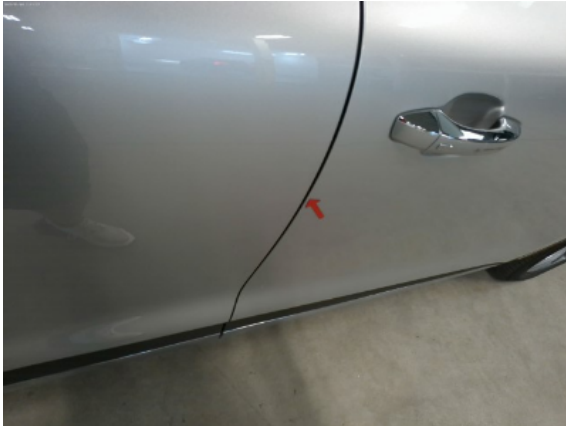
Image 5: Siehe Pos.5

| Nr. | Component | Damage | Severity | Comment |
|---|---|---|---|---|
| 5 | Door FR | Scratch | Slight | |
