REPORTNUMBER: 202403-25535

Report

Subject	Report
Inspection date/location	14.03.2024 Dick Automobile e.K., Ernst-Abbe-Str. 2, DE-36179 Bebra
Client	Dick Automobile e.K., Otto-Hahn-Str. 4-6, DE-36179 Bebra
Registration number	F-HR 500
Vehicle Identification Number	W1K1186141N122569

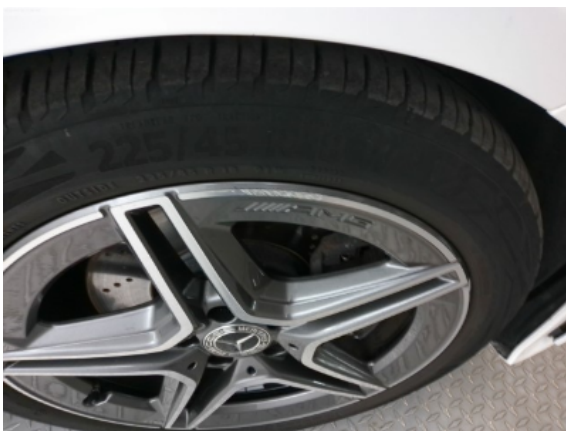
Image 1: Siehe Pos.1

Nr.	Component	Damage	Severity	Comment
1	Aluminium rim FR	Scratch	Medium	
2	Windshield	Crack	Severe	
3	Bonnet	Scratch	Severe	
4	Bumper front	Stone chip	Slight	
5	Door FL	Scratch	Slight	
6	Bumper rear	Scratch	Severe	
7	Door RR	Scratch	Slight	
8	Door entry RR	Scratch	Slight	
9	Door FR	Scratch	Slight	
10	Fender ri	Stone chip	Slight
